10th February 2021

Report on the failure of David Wilson Homes to comply with the planning permissions granted for Thurstan's Rise, Coleford:

**David Wilson Homes – Thurstan's Rise – Coleford
Failure to comply with planning permission**

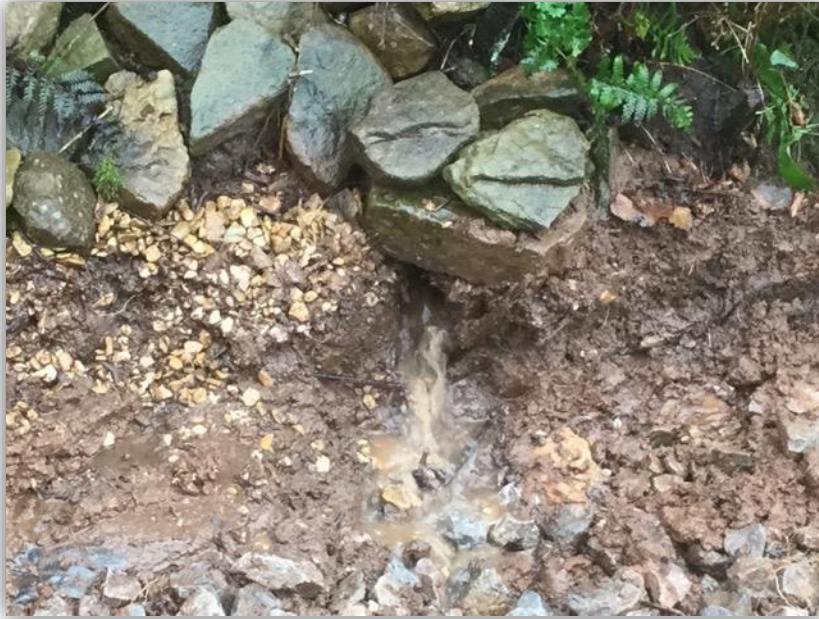
Presumably, in order to maximise the number of houses which could be built on the site, DWH decided to install 300mm (12in) diameter, 'twin-wall' perforated drainage pipe along three sections of the ditch adjacent to the field. The ditch was then back-filled with soil to cover the drainage pipe and provide these houses with a garden area. Since the soil on the site is mostly clay, which is largely impervious to water, this resulted in major problems for (in particular) plot 41, where the pipe was covered to about a metre depth with heavy clay, making drainage into the underground culvert virtually impossible.

This meant that the run-off from the field flowed across the garden of plot 41 ([View video](#)), and continued down the slopes on either side, also affecting plots 40 and 42, whose garages were subject to flooding.

Although DWH have now carried out remedial works at plot 41, digging out the back-filled pipe and installing a gravel filter drain along part of it, these works are unlikely to be fully effective due to the silting up of the underground culvert detailed below, and the sheer volume of run-off at that corner of the field.

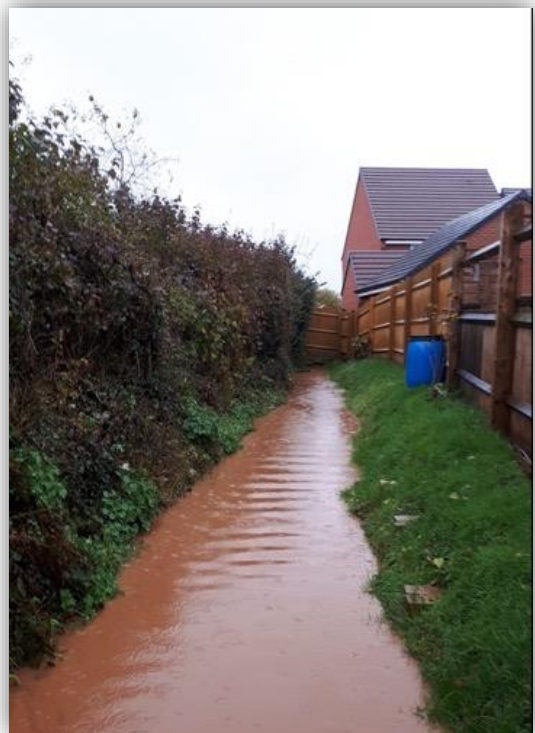
The first section of twin-wall, to the rear of plot 41, became silted up to about 1/3rd of its diameter after the winter of 2016/17, the first winter of occupation of plots 38 to 41.

This resulted in water flowing off the field at the corner adjacent to the Natural Burial Ground, backing up past the break of gradient between plots 39 and 40, and then flowing south into the adjoining ditch belonging to St John's C of E Primary Academy. This runs down the east side of plot 38 and caused flooding to the rear of the 'Two Rivers' housing association property at 30 Oakfields.

The silting of this section of culvert was reported to DWH in late 2016. They took no action other than to send their sub-contractors, EMG, to examine the problem. No attempt was made to clear the silt from the blocked culvert. Each subsequent winter has increased the level of silting of this section of twin-wall until it is now completely blocked, despite efforts by the owners of plot 40 to clear the entrance of silt.

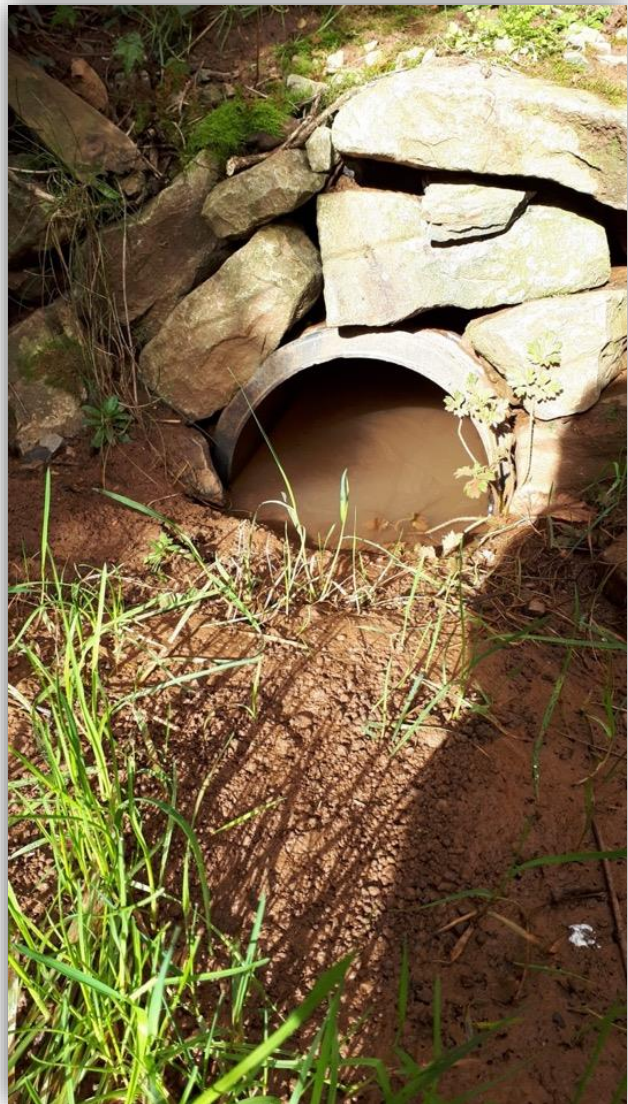
During the summer of 2018, with the permission of the school, the owner of plot 38 excavated the end of the eastern ditch and found that there is a 150mm (6in) pipe leading from the end of the ditch into an inspection chamber in the garden of 30 Oakfields. This however, had been blocked off using a large concrete block, and then back-filled with over a foot of clay soil. Possibly this was done by the builders to prevent polluted water from the site entering the council drains during construction, but according to the tenant at 30 Oakfields, flooding into their garden from the ditch had been a regular occurrence for several years. There is also a second 150mm drain pipe, leading into the same inspection chamber, which carries water from the traditional graveyard lying between the school and the Recreation Ground.

There is however, only a single 150mm outlet pipe from the inspection chamber which carries the water down the eastern side of the estate (on 'Two Rivers' land) and empties into the deep brick culvert at the rear of the re-sited children's playground in the central area of the estate ([View video](#)).

Concerns have been raised with the Council on several occasions about the safety aspects of this culvert and the dangerous drop into the headwall area, but, to date, no action has been taken.

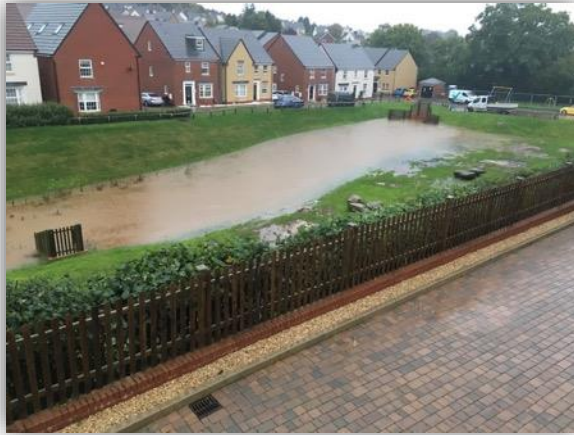
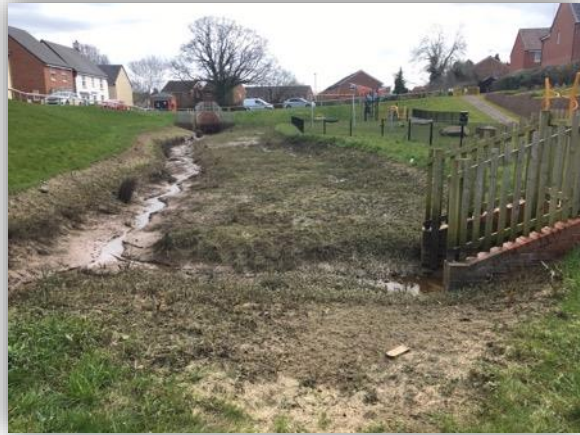
Sadly, neither the free-flowing brook nor the landscaped POS (public open space) has ever been the experience of the residents, due to the main drainage from the estate (Sluts Brook) being continually silted up, resulting in the POS being either under water, or a waste land:

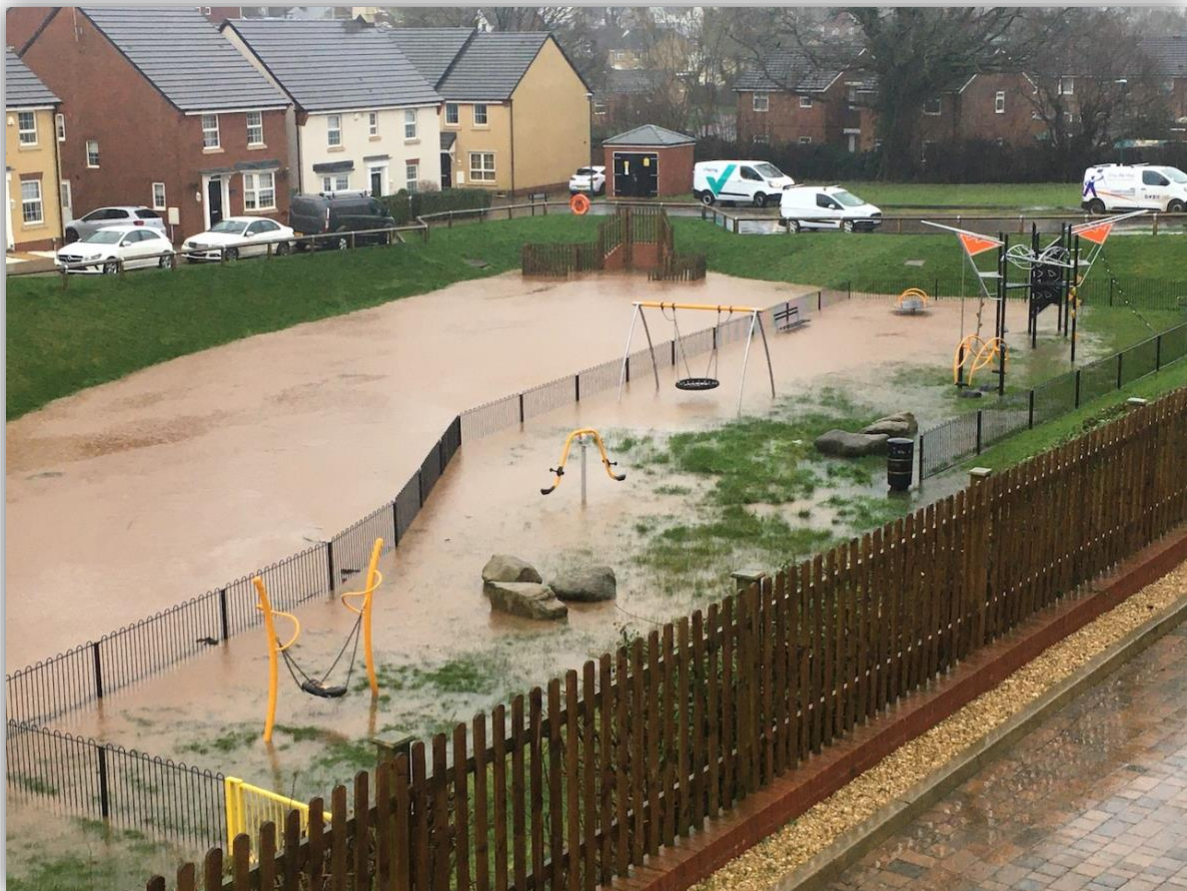
Prior to the LEAP (Local Equipped Area for Play) being re-sited (planning application P1112/19/FUL), the play park spent much of its life under water:

The probable cause of this is a blockage of the orifice plate by the quantity of silt washing off the surrounding fields and into Sluts Brook.

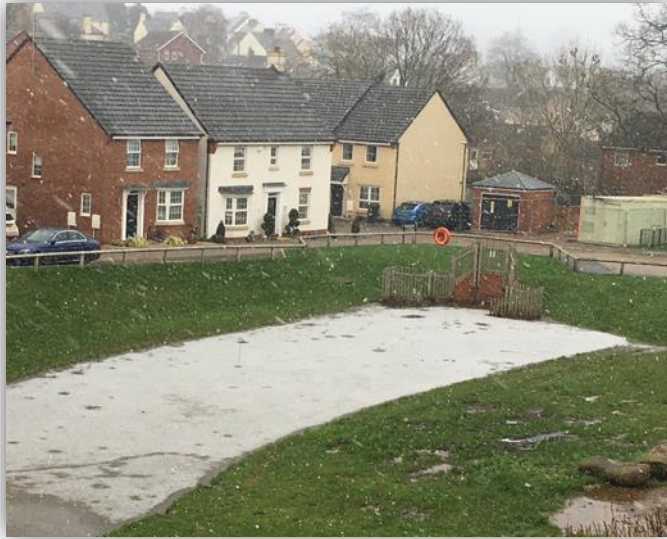
Not only is the area now smelly, unpleasant and unsightly when not full of water, it poses a significant danger – particularly to children – when it is.

The incidents over the Christmas and New Year periods when two children fell through the ice on the frozen lake highlighted this, and it is extremely fortunate that to date there have been no fatal accidents.

The TRRA undertook to erect a safety notice warning of thin ice, but in view of the nature of the danger, it is obvious that a permanent solution must be found as a matter of urgency.

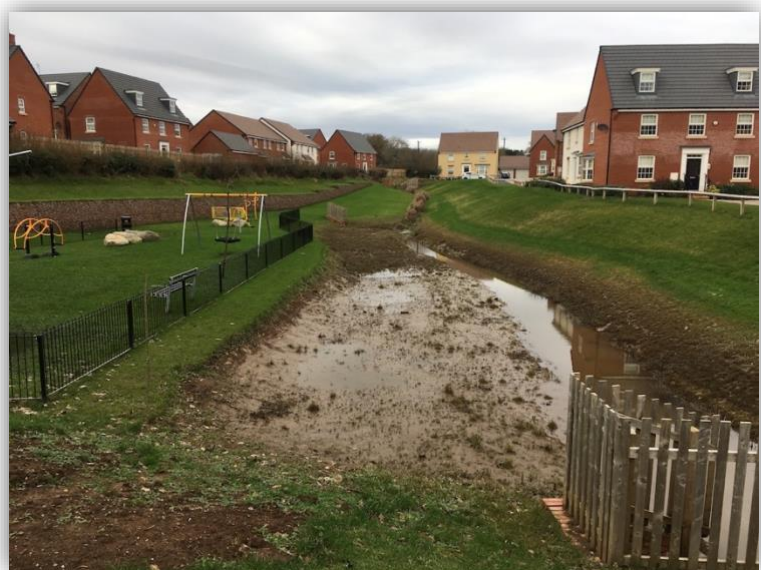
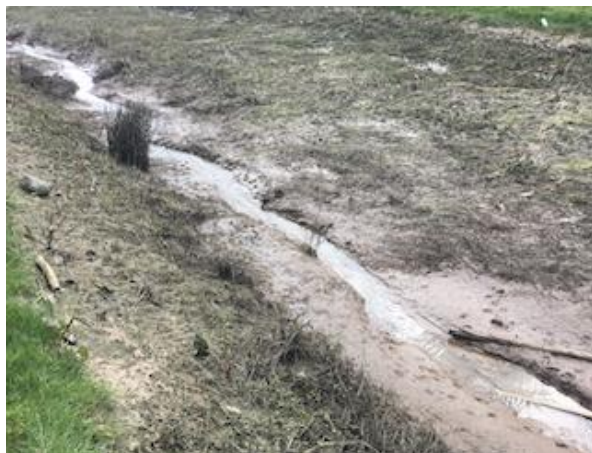
The Public Open Space (currently Lake Caudwell) remains a waste land when it isn't flooded (during 6 months of the year), despite this supposedly being one of the main features of the Thurstan's Rise planning concept.

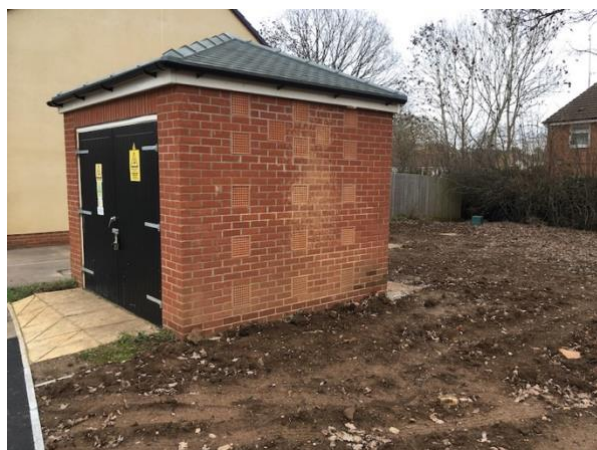
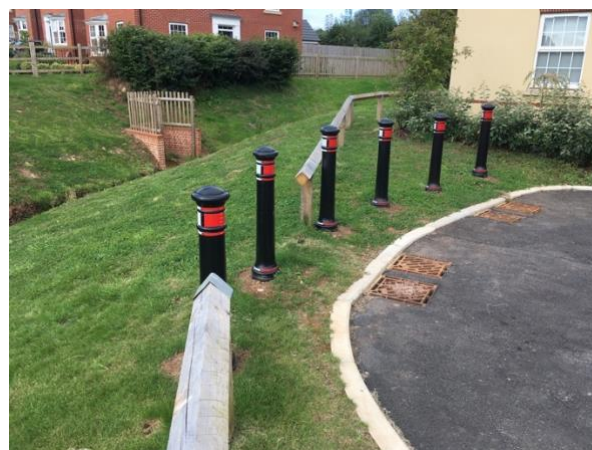
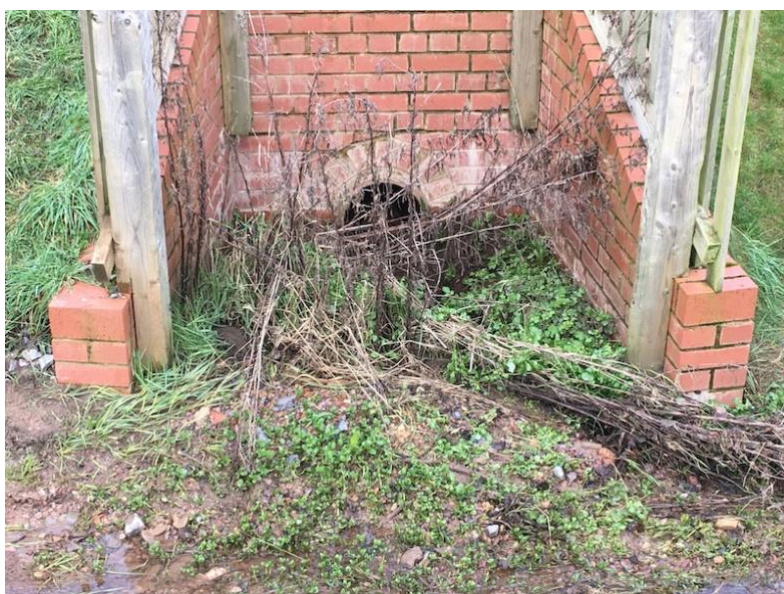
Around the electricity substation (and adjacent parking area) 47 hedging plants and 26 shrubs are detailed on the plan; however, none are in evidence. And the knee-rail section at the bottom of Inwood Drive – removed when bollards were installed – awaits reinstallation:

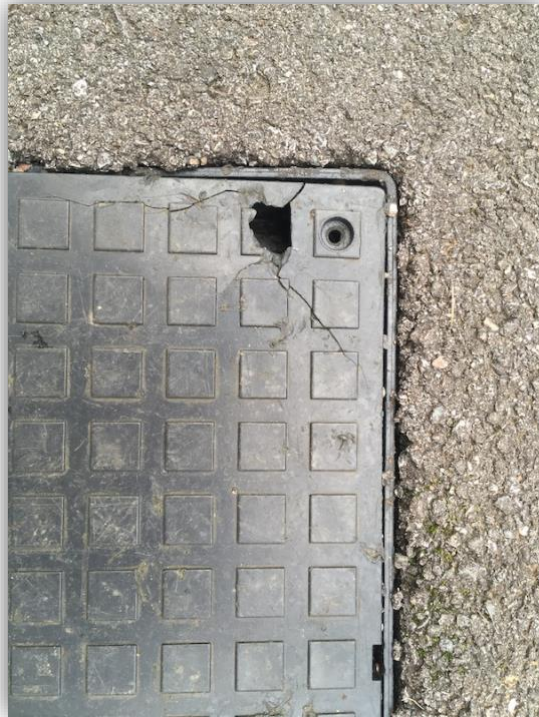
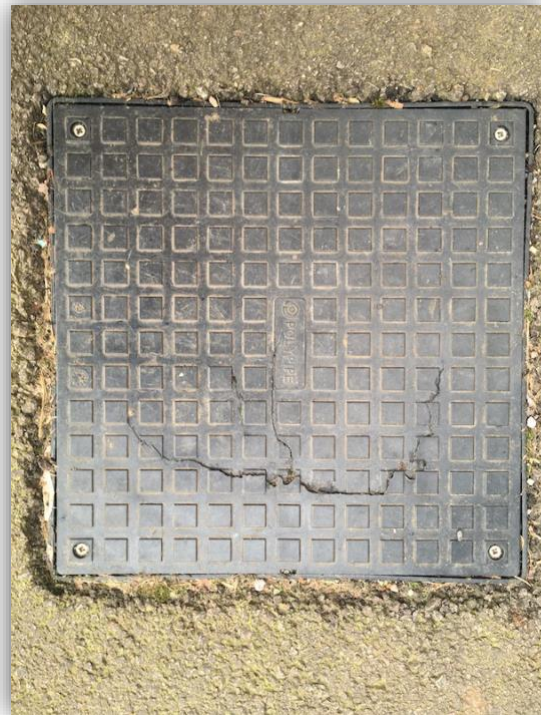
Many of the 'Polypipe' plastic drain covers that have been installed on property driveways are only rated as 'pedestrian' (FACTA A – 5kN) which is in breach of building regulations and, unsurprisingly, they have cracked when driven over:

DWH assured us, last summer (2020), that an audit would be undertaken across site to ascertain which drain covers had been incorrectly installed and that these would be replaced with correctly specified ones. However, this hasn't happened and many of the existing drain covers remain contrary to building regulations, whilst also representing a health and safety issue.

- 1) recognise and rectify the inadequate drainage solutions that currently exist on the site, both with regard to the incorrectly graded culverts and filter drains on the western boundary of the development, and also the major problem of flooding within the public open space.
- 2) complete all landscaping works, as per the planting schedule provided within their submitted documentation.
- 3) replace all the incorrectly specified drain covers to meet building regulations.
