10th February 2021

Report on the failure of David Wilson Homes to comply with the planning permissions granted for Thurstan's Rise, Coleford:

**David Wilson Homes – Thurstan's Rise – Coleford
Failure to comply with planning permission**

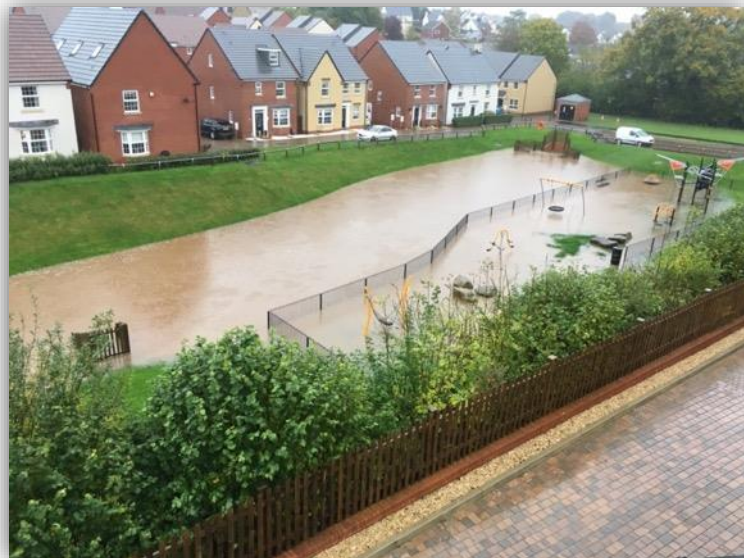
The gradient of the ditch breaks roughly between plots 39 and 40, meaning that from that high point about 90% of the water running off the field and part of the Natural Burial Ground, should flow to the north, joining the ditch running down the private farm road. This should then join Sluts Brook, and flow into the central area designated as 'Public Open Space' (POS) now known locally as "Lake Caudwell".

Presumably, in order to maximise the number of houses which could be built on the site, DWH decided to install 300mm (12in) diameter, 'twin-wall' perforated drainage pipe along three sections of the ditch adjacent to the field. The ditch was then back-filled with soil to cover the drainage pipe and provide these houses with a garden area. Since the soil on the site is mostly clay, which is largely impervious to water, this resulted in major problems for (in particular) plot 41, where the pipe was covered to about a metre depth with heavy clay, making drainage into the underground culvert virtually impossible.

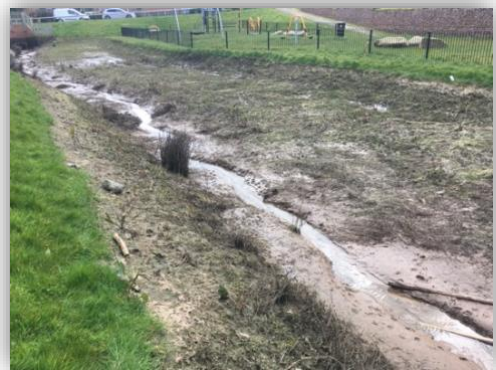
The central area of the estate contains the valley of Sluts Brook, one of three streams which join (now in underground culverts) in the centre of Coleford. This brook rises from a natural spring near Crossways, and flows across the field to the northwest of the estate before entering the central public open space between Inwood Drive and Cadora Way. For parts of the year, the brook is little more than a trickle, or completely dries.

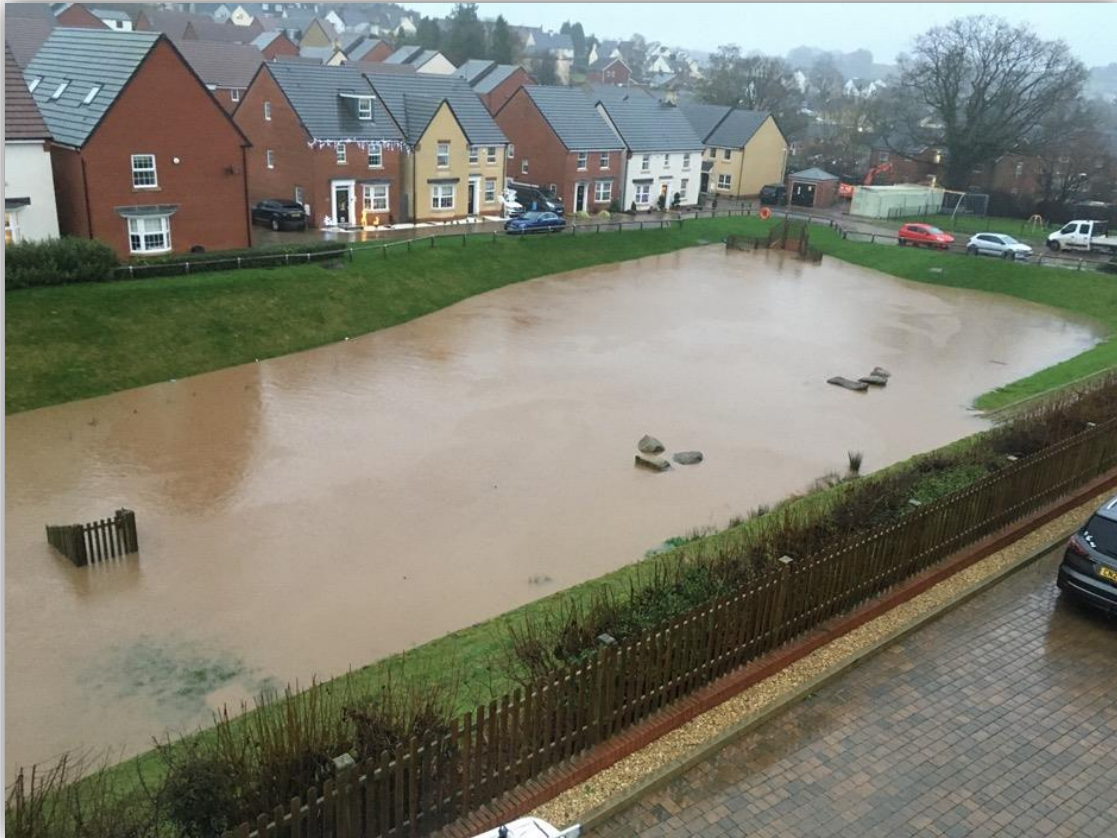
In winter however, as well as what emerges from the spring, it forms the main drainage channel for all the surrounding fields, and can swell very quickly into a raging torrent carrying a heavy load of silt ([View video](#)).

Historically, Sluts Brook has been the cause of regular minor flooding in the neighbouring Oakfields estate. Since the building of Thurstan's Rise estate, the increased rapid run-off from hard concrete and tarmac surfaces means that water is channelled into this section of the brook much faster than it was previously. In 2015, during the building of the estate it was the cause of a major flood in Oakfields, which resulted in several vehicles in the car park there being seriously damaged. Following this incident, steps were taken to moderate the flow of the brook, to avoid sudden large volumes of water overwhelming the capacity of the culverts below Oakfields, and further downstream.

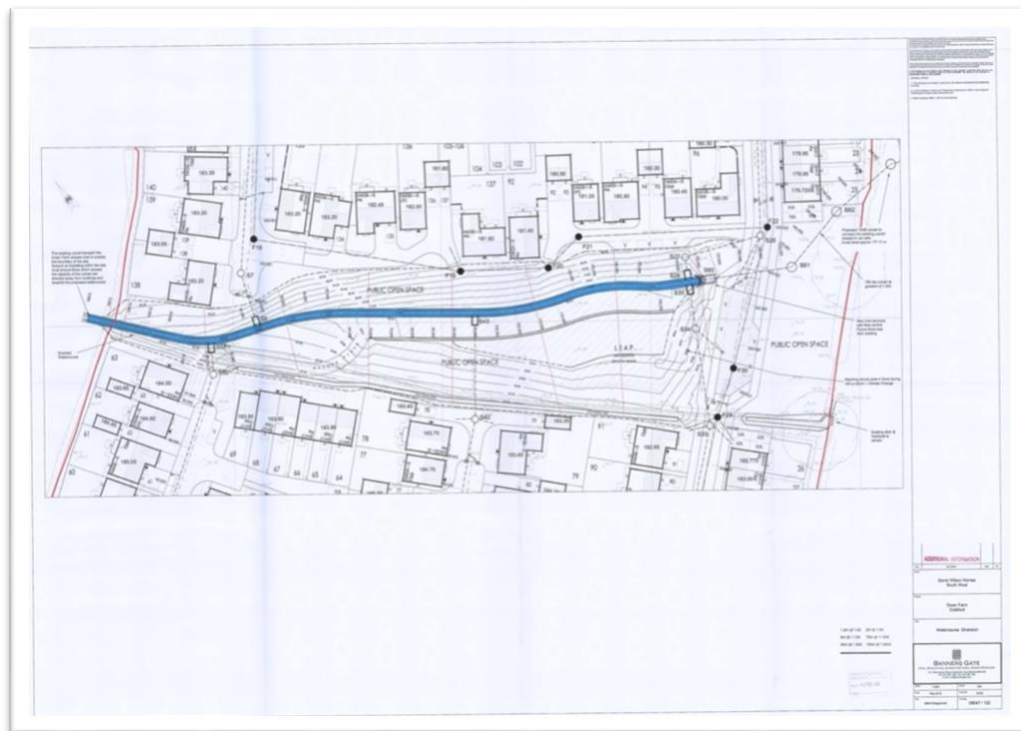
This should mean that for most of the year, the central public open space is either dry or contains a small free-flowing brook. Below is the plan, submitted by DWH, to show the watercourse diversion:

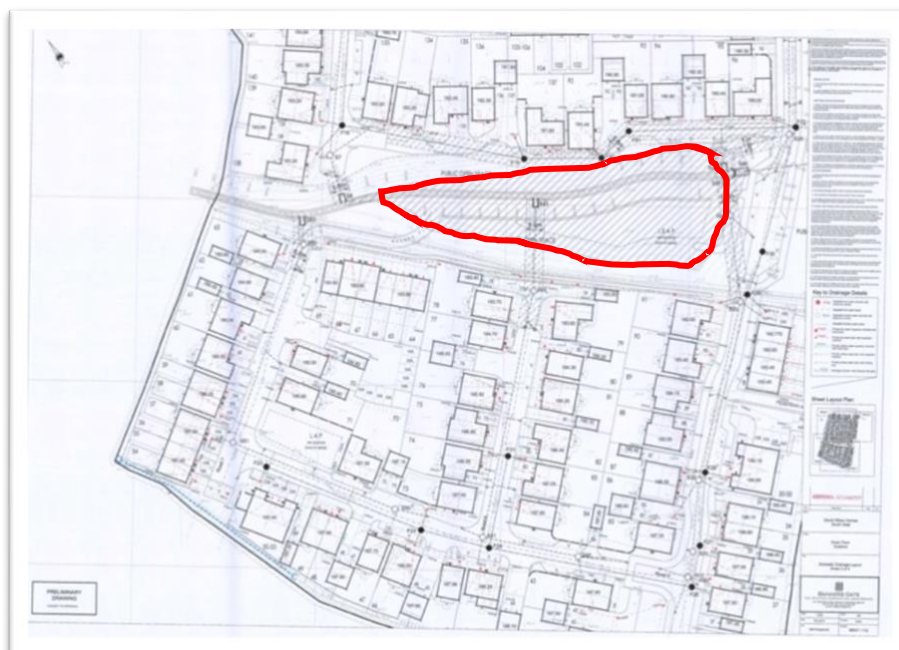
A provision was shown in the DWH proposed drainage layouts (as submitted for planning permission) for the public open space to 'double' as a flood storage area for a "100-year flood" (shown below with a red outline):

This means that DWH were predicting that there was only a 1 in 100 chance (1% probability) of a 'flood event' being equalled or exceeded in any given year.

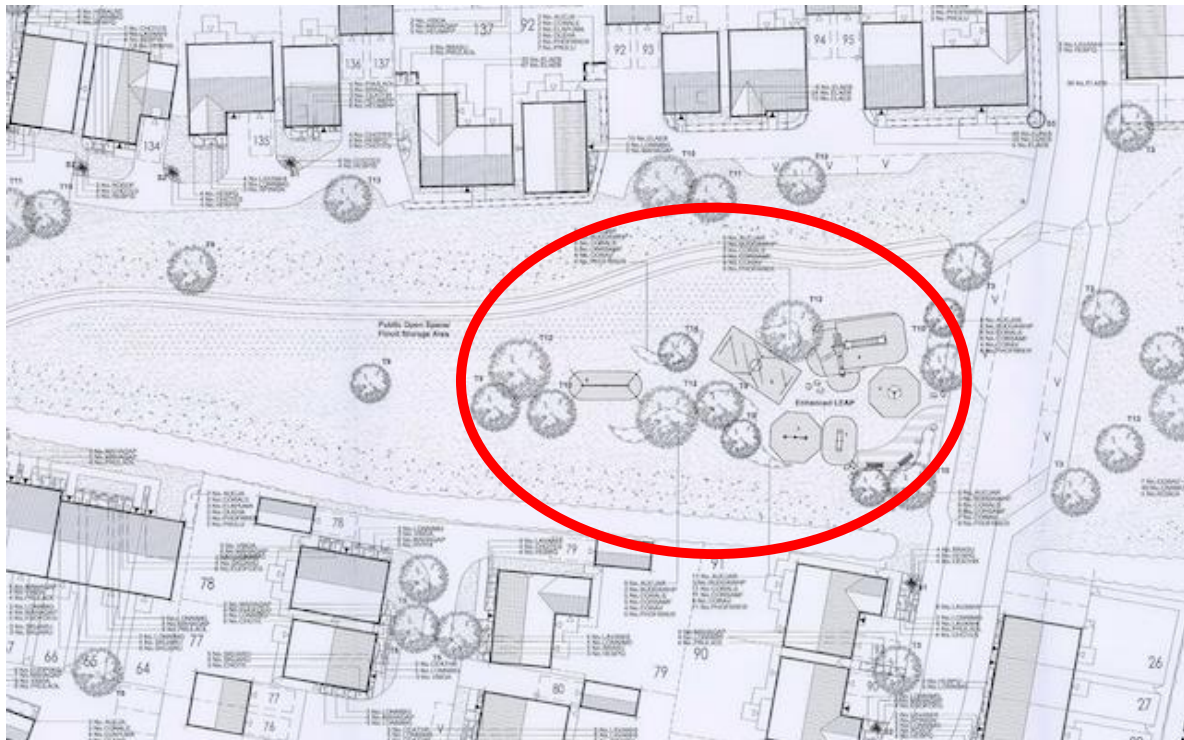
DWH have continually maintained that the estate main drainage system (Sluts Brook) is working perfectly and that "Lake Caudwell" was always planned as a 'balancing pond', even though there is no reference what so ever to this on any of the drainage or landscape plans submitted to Planning.

It is also worth noting that if a balancing pond was intended, as they claim, then why also plan build a children's play park (LEAP) in the middle of it.....?

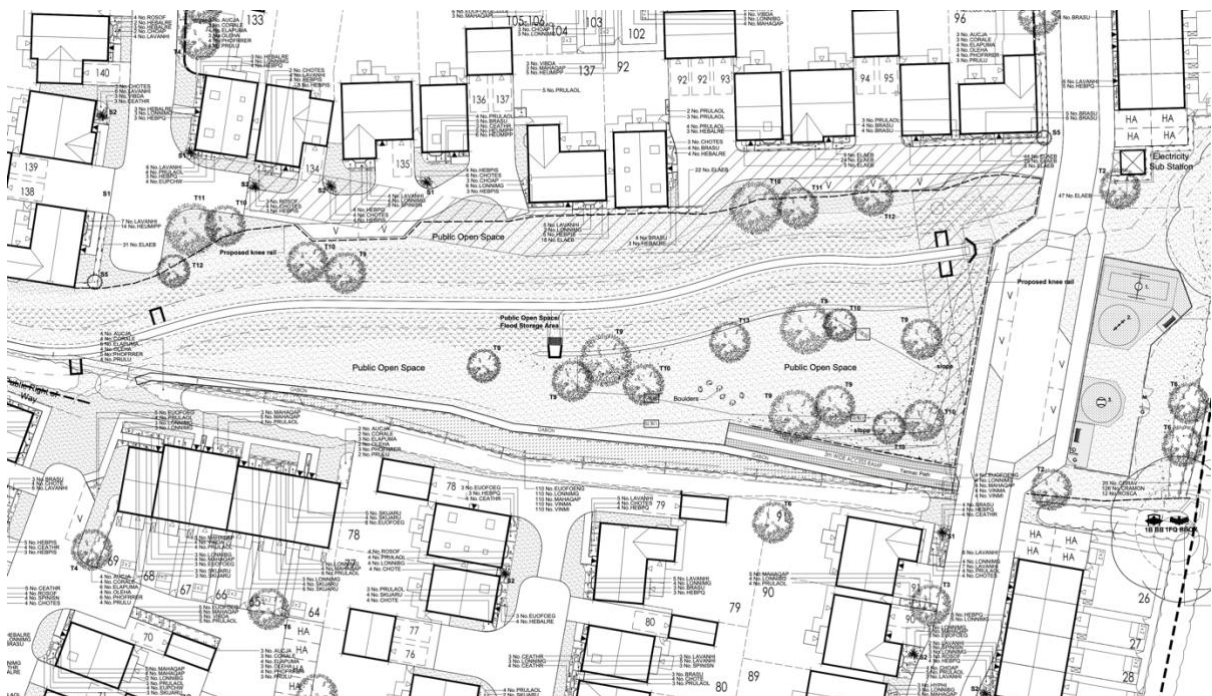
Despite numerous requests to DWH over the past four years (and many broken promises from their directors), DWH have continually failed to complete much of the landscaping across the site, as per their submitted landscaping proposals (P1251/12/FUL and P1112/19/FUL) and as specified in their most recent drawings:

An example of which is shown below:
